**2011 Operations, Maintenance,
and Monitoring Report**

**Cote Blanche Hydrologic
Restoration**

State Project Number TV-04
Priority Project List 3

July 2011
St. Mary Parish

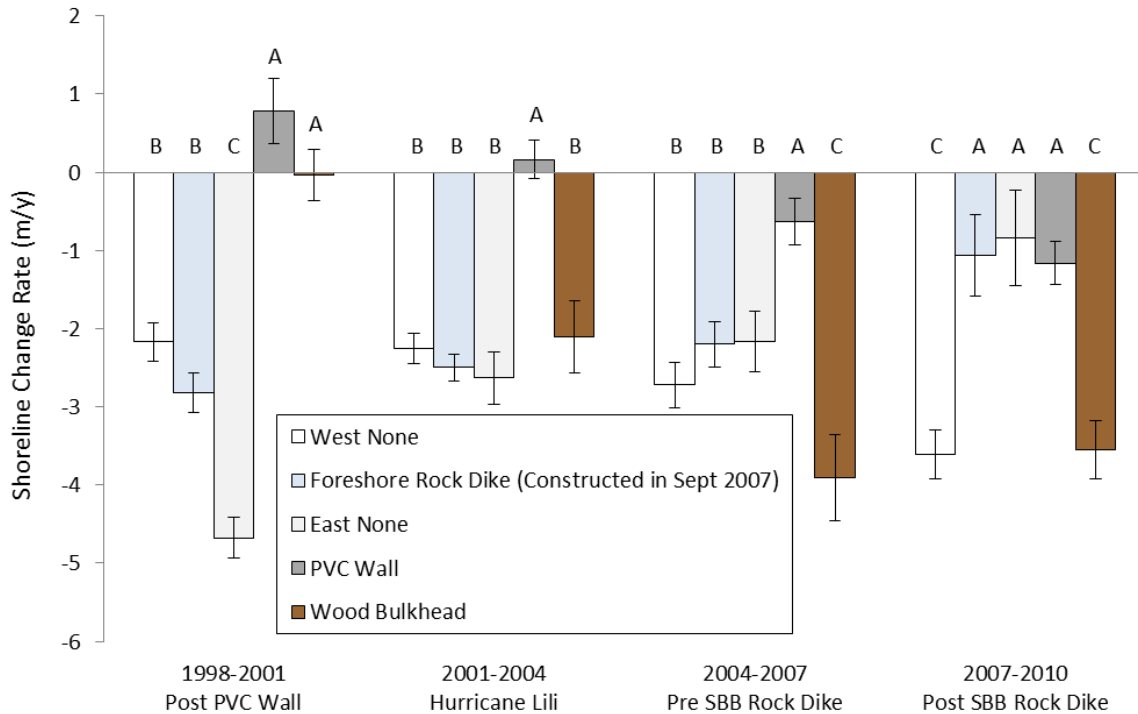
Shoreline protection measures have decreased erosion relative to unprotected shorelines although erosion has increased since Hurricanes Lili (2002), Rita (2005), and Gustav and Ike (2008). The relationship among the shoreline protection types changed over the time intervals (shoreline \times time, $F_{4,3}=10.4$, $p<0.0001$, figure 4), and shoreline change rates differed among shoreline protection types overall (1998-2010, $F_4=44.1$, $p<0.0001$, figure 5). The western unprotected shoreline erosion increased over time by 1.4 m/y (4.6 ft/y). Shoreline erosion behind the foreshore rock dike significantly decreased after installation in 2007 ('04-'07 > '07-'10, $t_1=2.5$, $p=0.0135$; figure 4, 5, and 6) despite rock settling to below the target elevation. The eastern unprotected shoreline had similar erosion rates as the western unprotected shoreline until it decreased inexplicably during the 2007-2010 interval (figure 4 and 6). Overall since construction, the shoreline behind the foreshore PVC wall eroded significantly less than all other shoreline reaches; however, the effectiveness has decreased since Hurricane Lili as the shoreline was prograding through 2004 and then eroding thereafter. During the last interval (2007-2010), erosion behind the PVC wall was 3 times less than the western unprotected shoreline but similar to the eastern unprotected shoreline. Although the protrusion of the shoreline behind the pre-existing wooden bulkhead is quite visible (figures 1,

Figure 4. Intervals of shoreline change rates were calculated from shoreline mapping conducted along protected and unprotected shoreline of East Cote Blanche Bay within the TV-04 project area from 1998-2010. Significant events affecting the shoreline in the time intervals were: 1998-2001, initial post construction of the PVC wall east of Humble Canal; 2001-2004, Hurricane Lili; 2004-2007, pre construction of the foreshore rock dike parallel to School Bus Bayou and Hurricane Rita; 2007-2010, post construction of the SBB rock dike and Hurricanes Gustav and Ike. Significant differences among shoreline protection types within each time interval are indicated by different letters (Tukey's HSD post test).

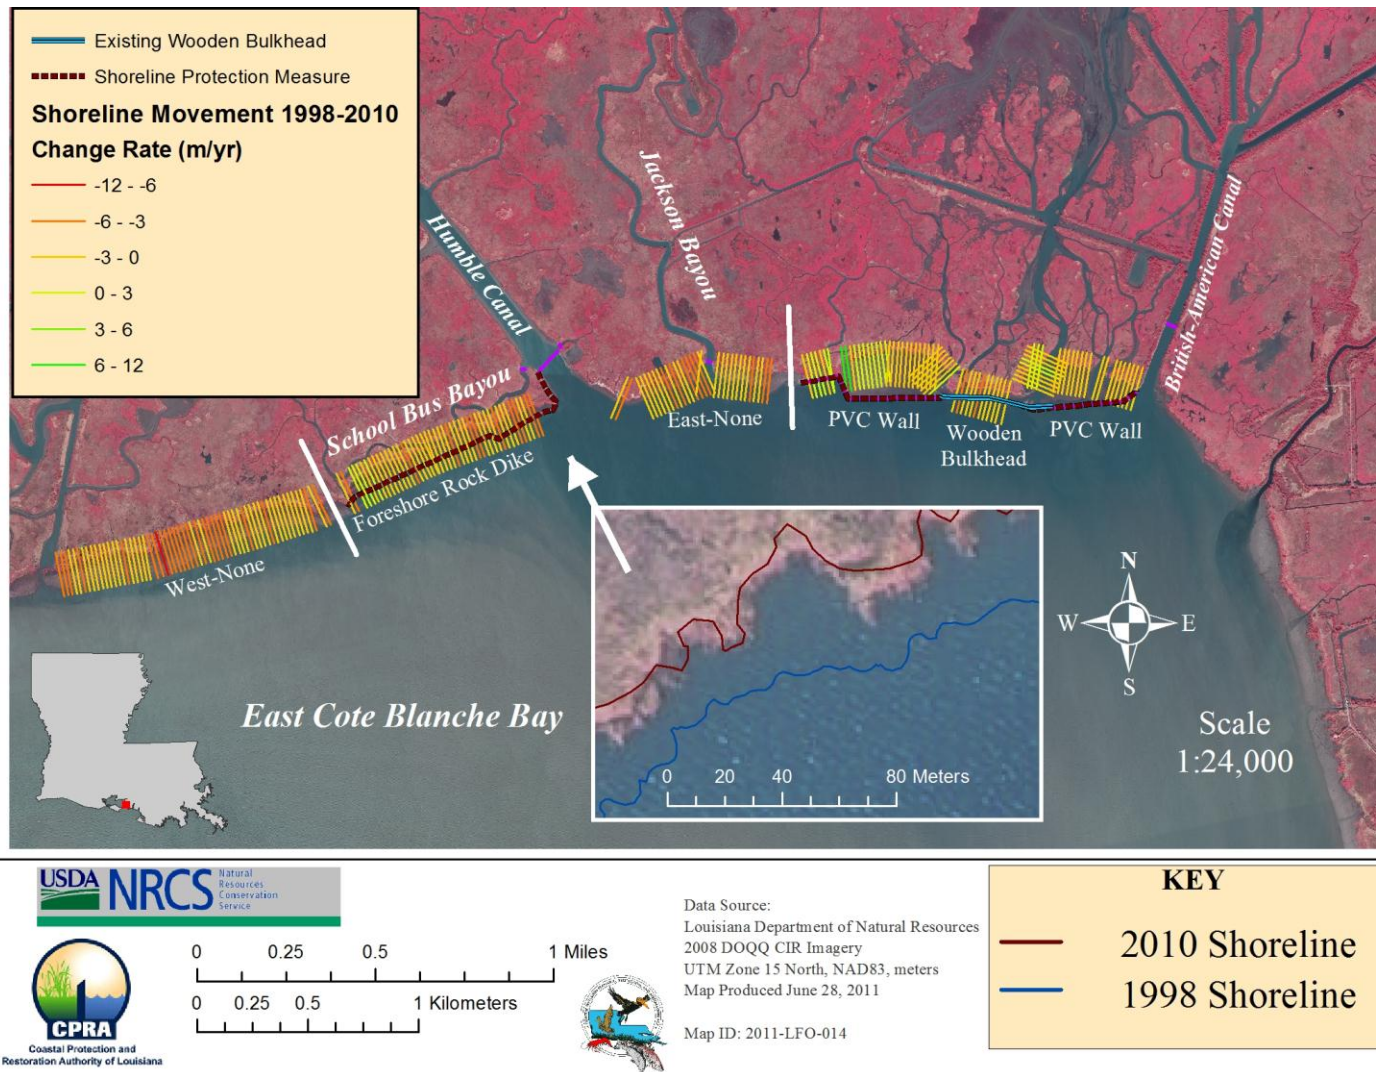
5, 6), it has eroded at the same rate as the west unprotected shoreline since Hurricane Lili as its condition and effectiveness becomes more dilapidated over time (figures 4, 5, 6).

Figure 5. Cote Blanche Hydrologic Restoration (TV-04) shoreline change over the life of the project (1998-2010). The Foreshore Rock Dike was not constructed until 1997, and the Wooden Bulkhead was a pre-existing structure constructed in the late 1950s.

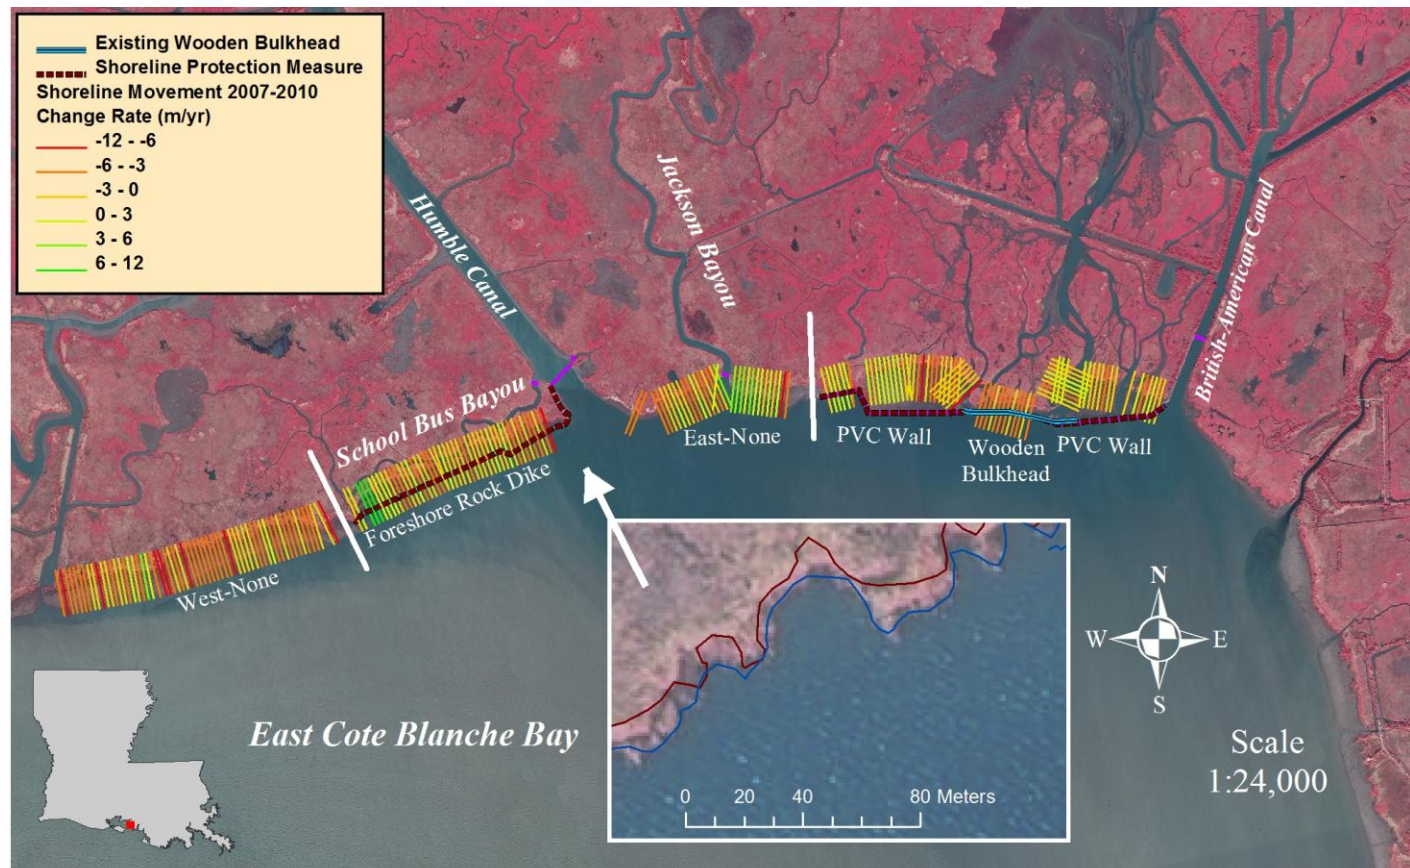
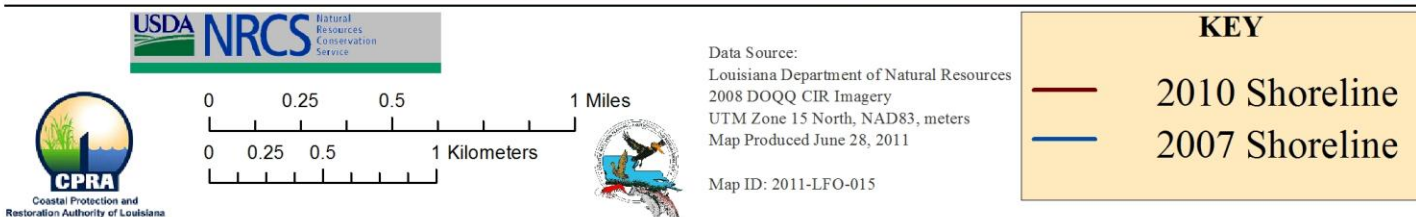
Figure 6. Cote Blanche Hydrologic Restoration (TV-04) shoreline change from 2007 to 2010. The Foreshore Rock Dike was constructed in 2007, and the Wooden Bulkhead was a pre-existing structure constructed in the late 1950s.

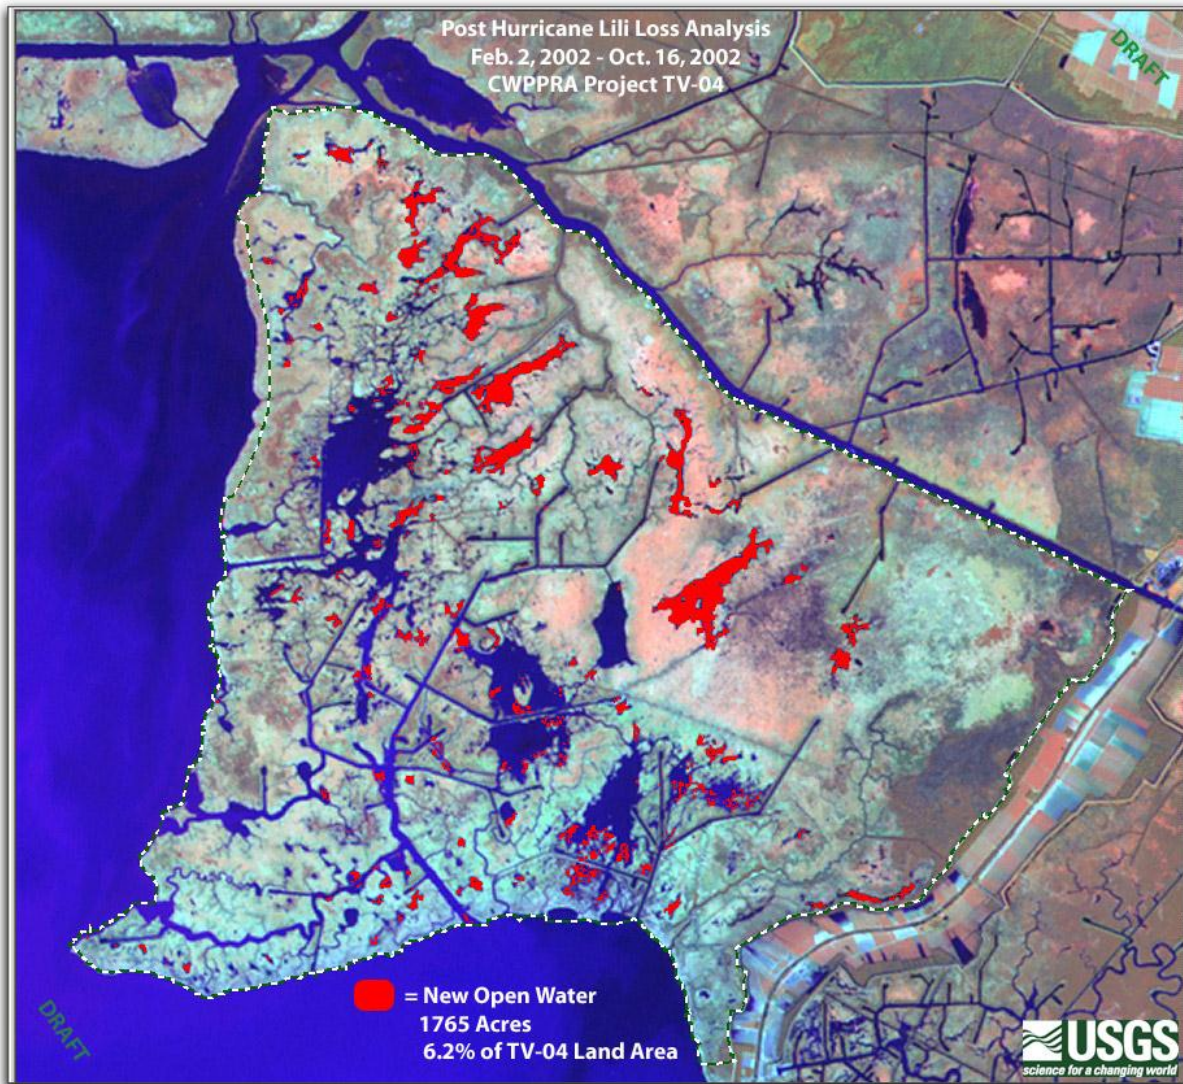
Figure 8. Land to Water change analysis (February 2002 – October 2002) resulting from Hurricane Lili (10/3/02). Satellite imagery and analysis provided by U. S. Geological Survey.
